## Semi-ceramic Lunac 2+ (duplex) atomic deposition coating

As a typical hydraulic cylinder and axle coating, Lunac 2+ duplex (L2+D) is among,

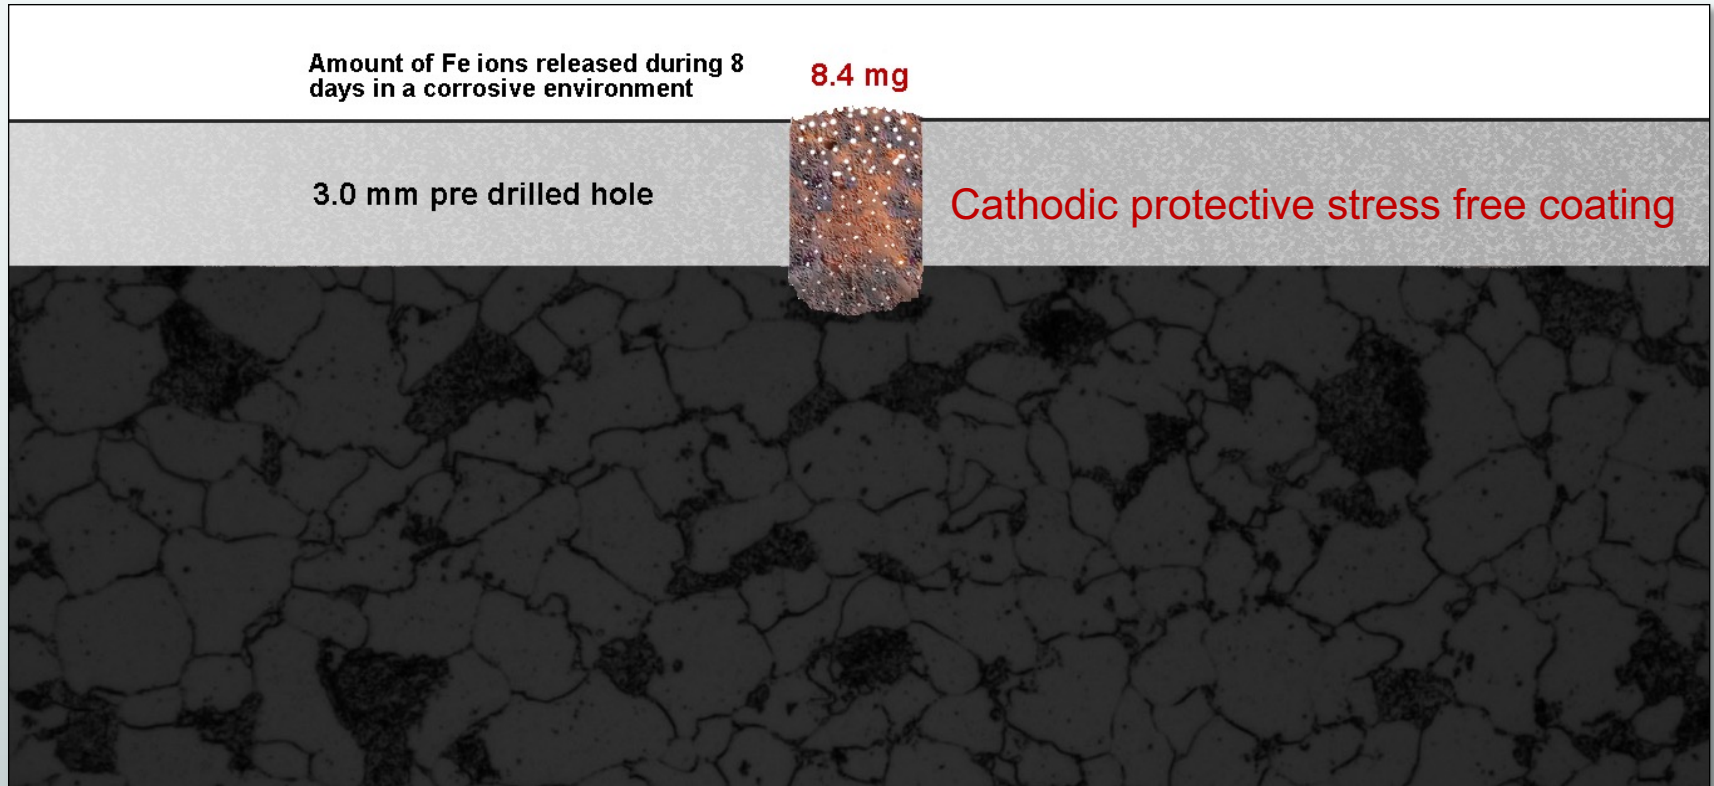
# Sub-surface corrosion inhibition by stress free and/or cathodic protective coatings.

The amount of Fe-ions being released from a drilled hole in L2+D coated S355J2 steel during similar condition. No significant sub-surface corrosion is observed and consequently no raised sharp edges emerge. Main reason L2+D barely returns for overhaul.

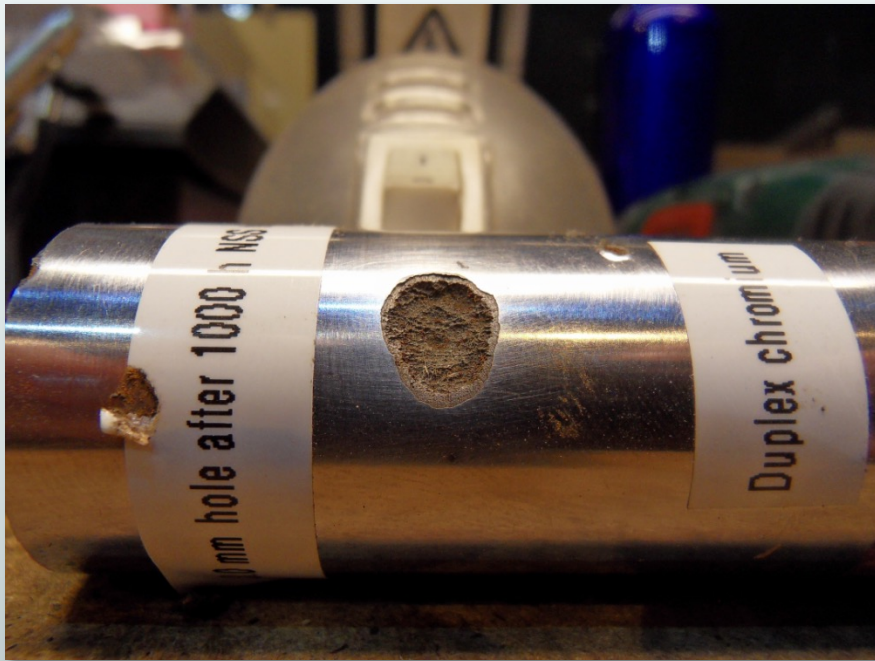
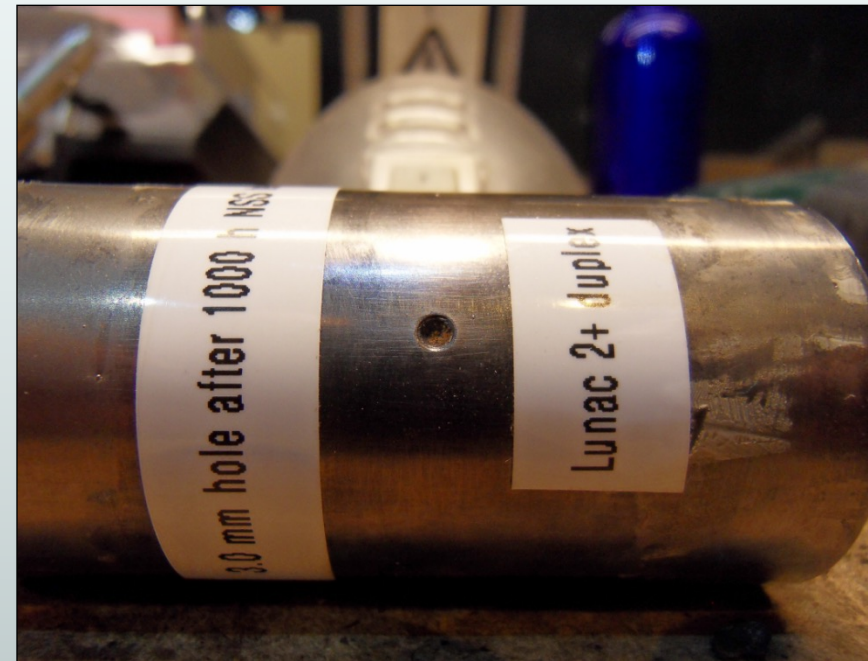
# Duplex chromium/steel vs. L2+D/steel after 1000 h salt spray testing (original hole: 3.0 mm).

The originally hole in the duplex-chromium plated rod (left) has widened to  $\text{Ø}$  12 mm during this test period. The hole in the L2+D coating remained unchanged.

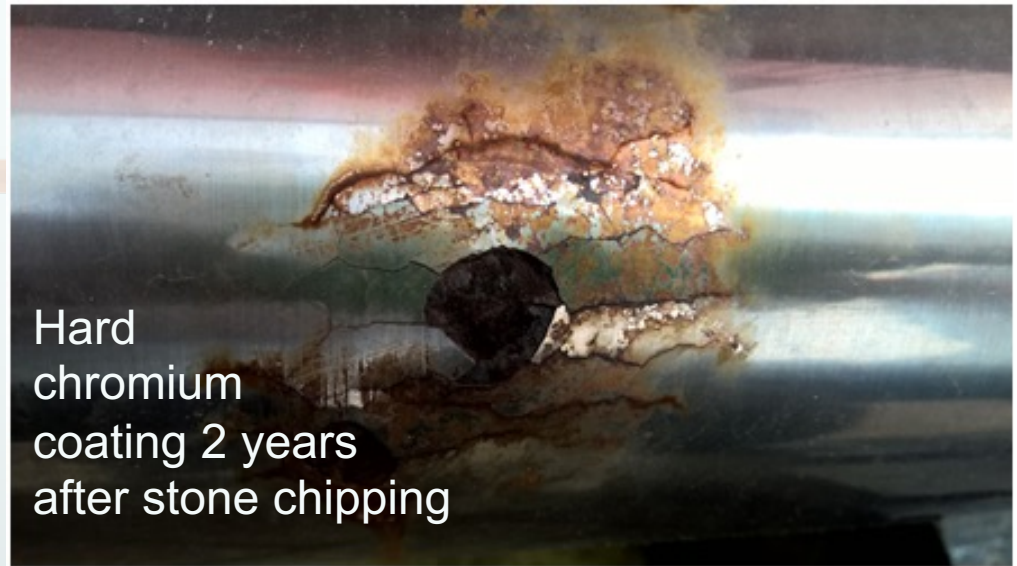
Hard  
chromium  
coating 2 years  
after stone chipping

**Off shore piston rod cases,  
2 and 4 years after damage**

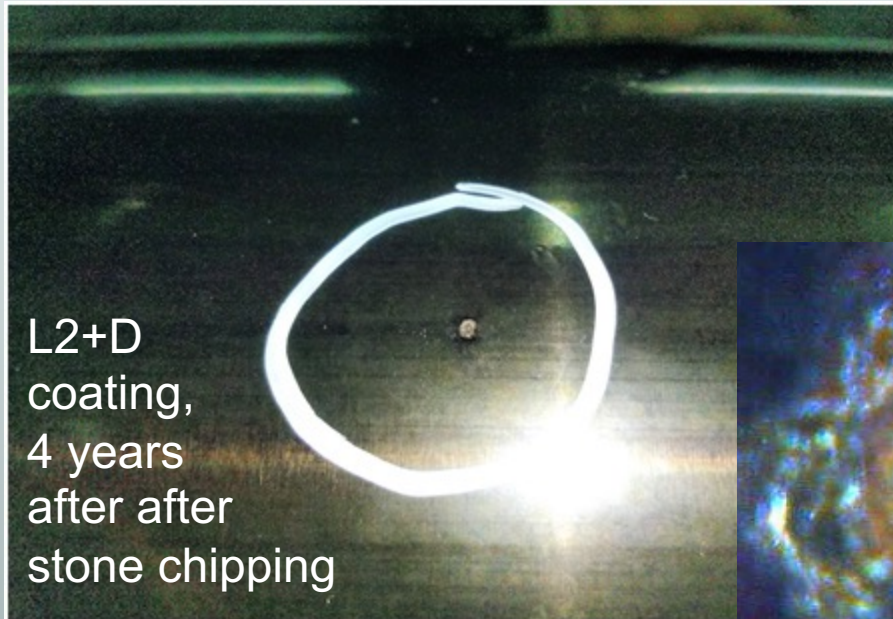
L2+D  
coating,  
4 years  
after after  
stone chipping

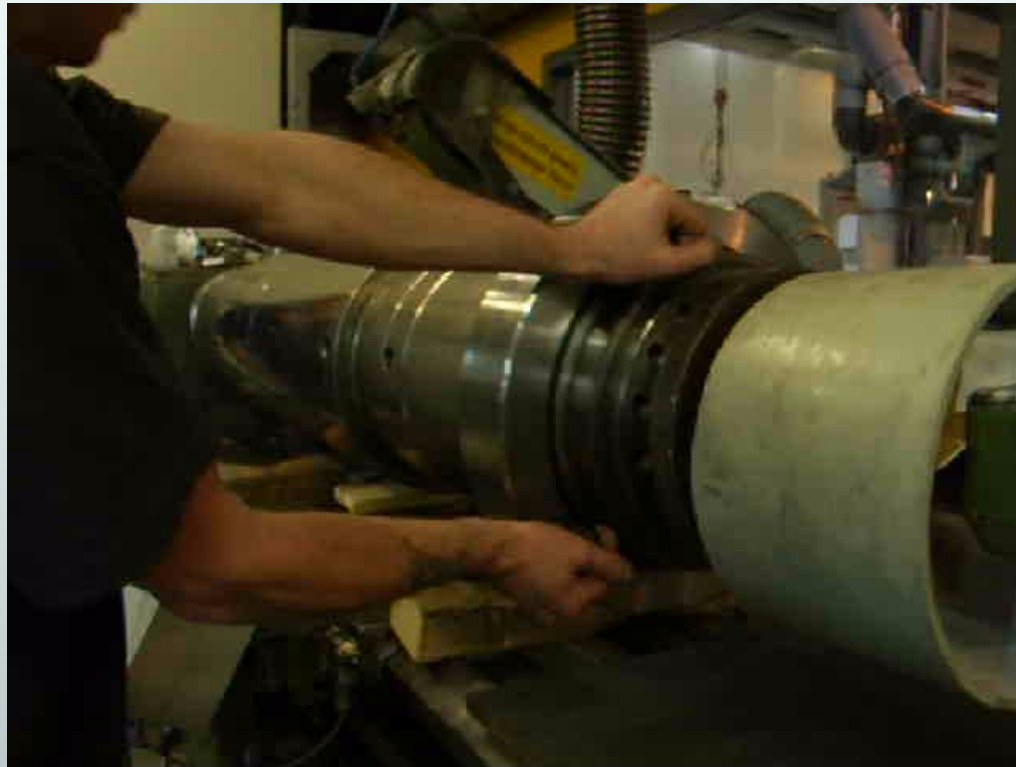
Impeller pitch control axle Spanish hydro-electric power plant.

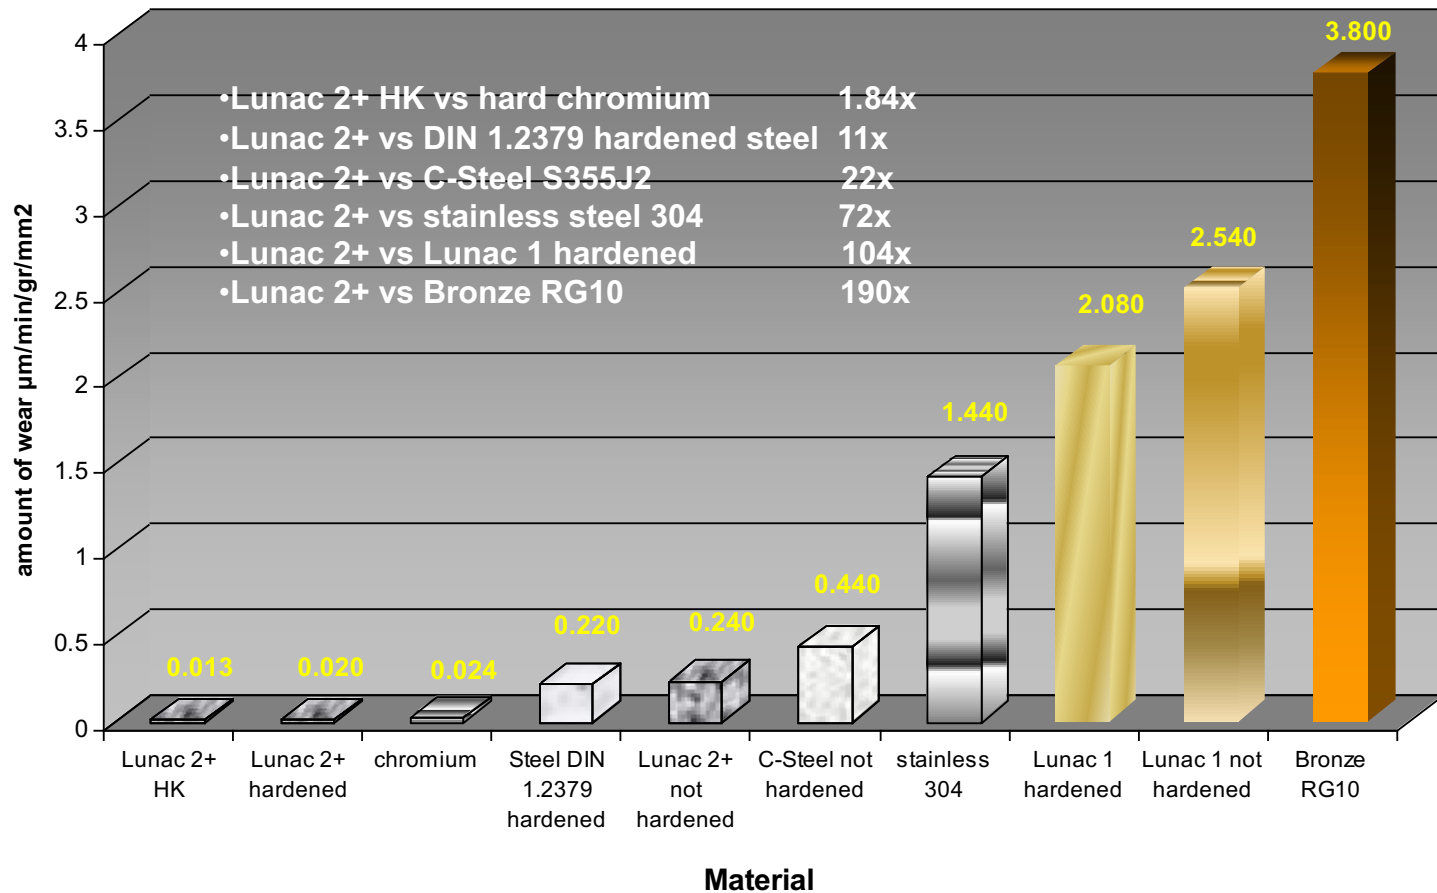
# Tabor abrasive wear resistance based on SiC mineral testing

Abrasive wear taber test SiC grit 800, 1.98 m/s

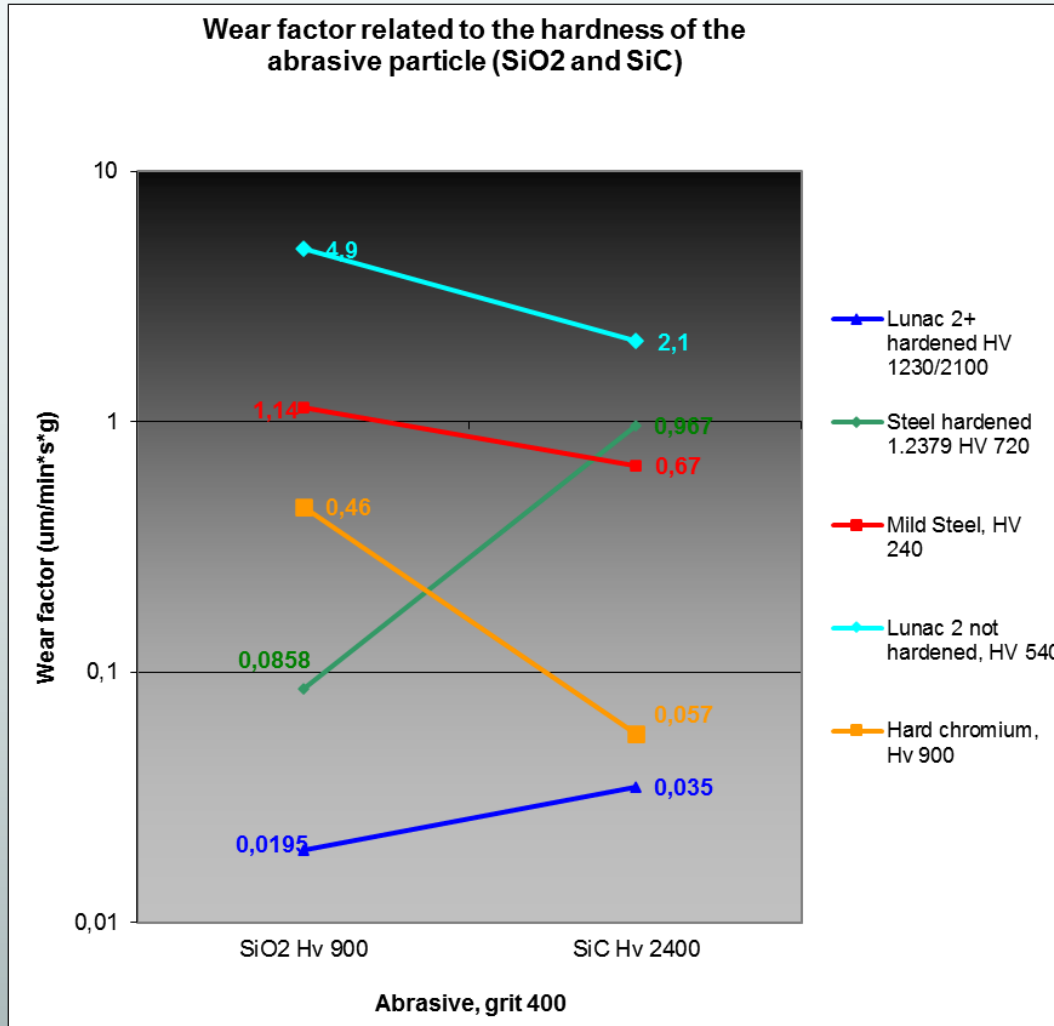
# Influence of abrasive particle hardness

Amount of hardchromium HV 900 wear vs. Lunac 2+ HV 1150/2100

SiC (Carborundum) : 1.6 X  
SiO<sub>2</sub> (Quartz) : 24 x

Interestingly the best abrasive wear resistance of Lunac 2+ is recorded in a quartz sand environment

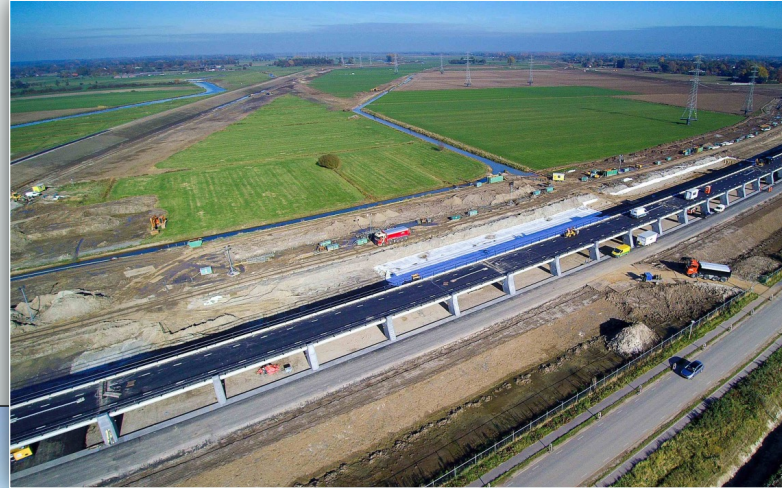
Veessen-Wapenvelddam 2016. All central 42CrMo4 steel hinges are L2+D coated, because of the long service life demand. According to RWS NBD10300 directive

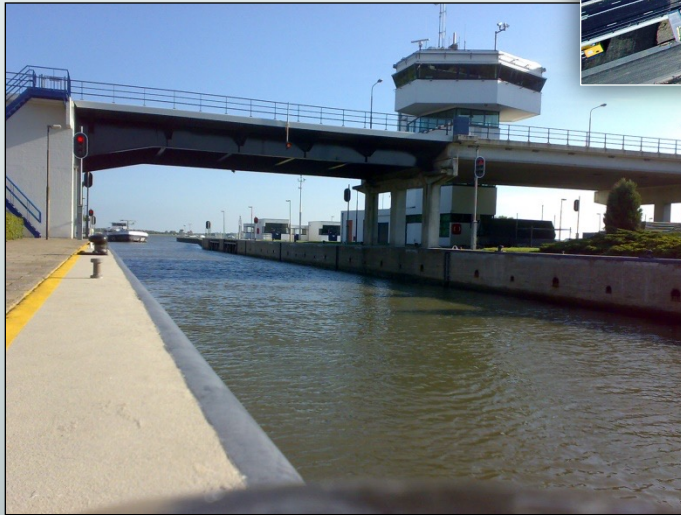
Houtribsluizen (Lelystad) L2+D coated lock gate hinges.

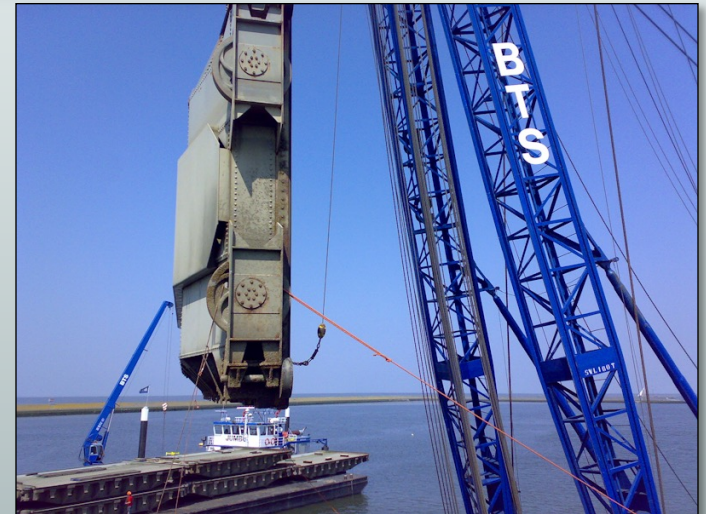
Waddenzee (Kornwerderzand) lock gate axles, coated with Lunac 2+ (2005)

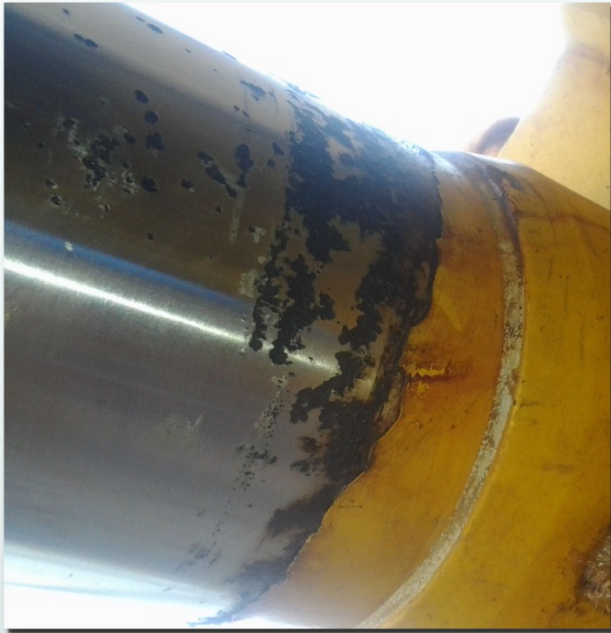
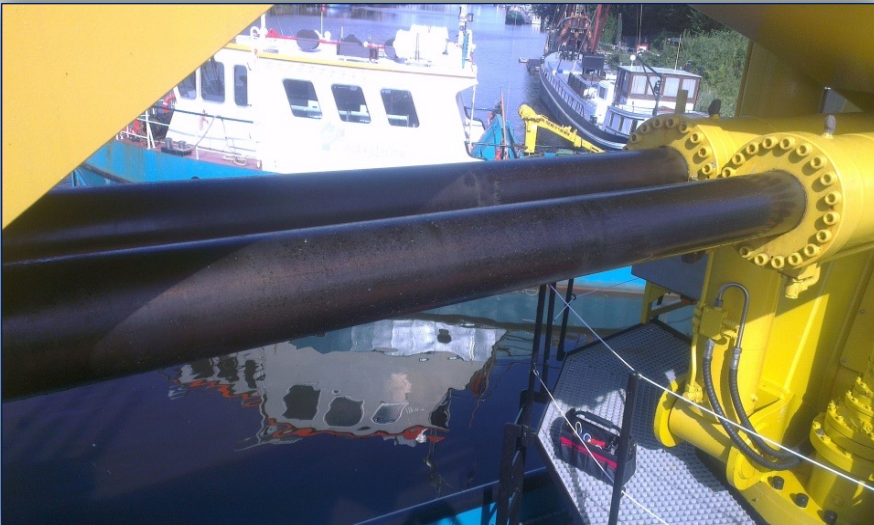
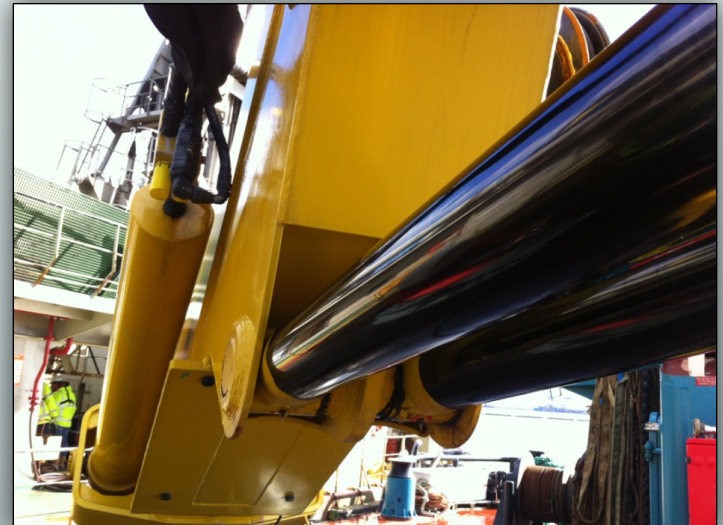
Chromium plated carbon steel cylinder after 27 months (left) in a marine environment clearly displays the detrimental sub-surface corrosion effect.

Lower right: L2+D coatings (after 36 months, similar conditions) also offer good protection in the last **never retracted** zone ! Note; these cylinders can also be exposed to corrosive  $\text{SO}_2$  containing exhaust gasses.

Lower-left: L2+D coated cylinder exposed to intensive sand wear for 2 years. The  $0.2 \mu\text{m}$  patina layer is still present.

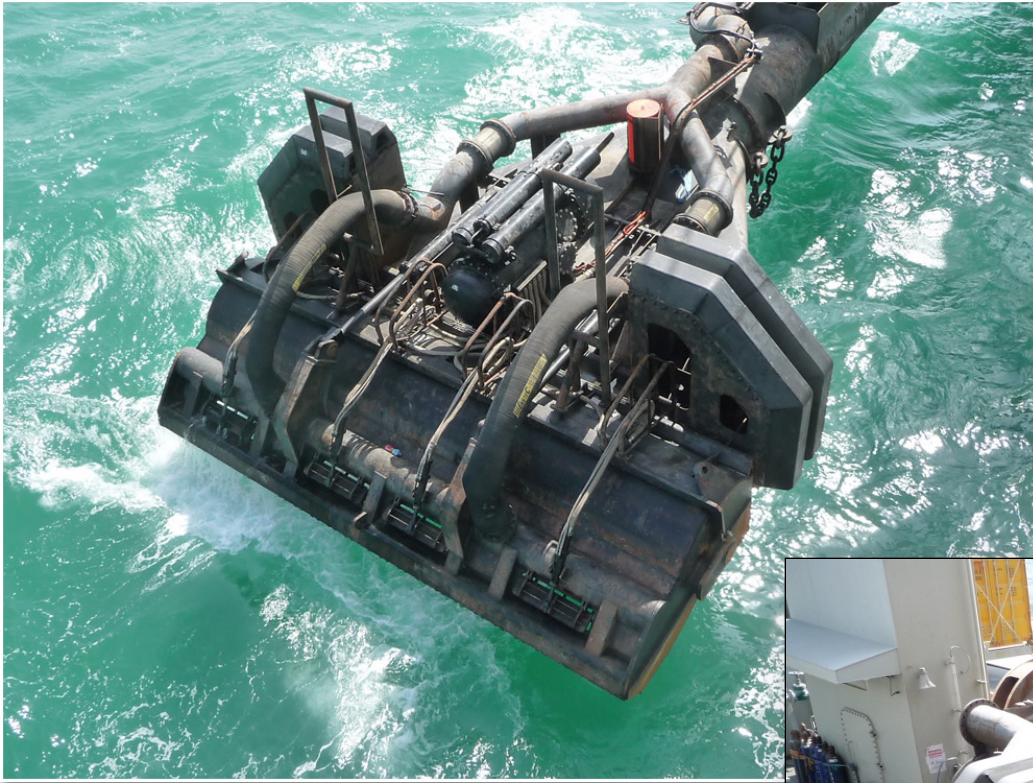
Governing dredging cylinders L2+D coated for reasons of corrosion protection, wear resistance and especially the capability to deal with **stone chipping**. This is caused by the relatively good L2+D **semi-ceramic ductility** and full substrate bond.

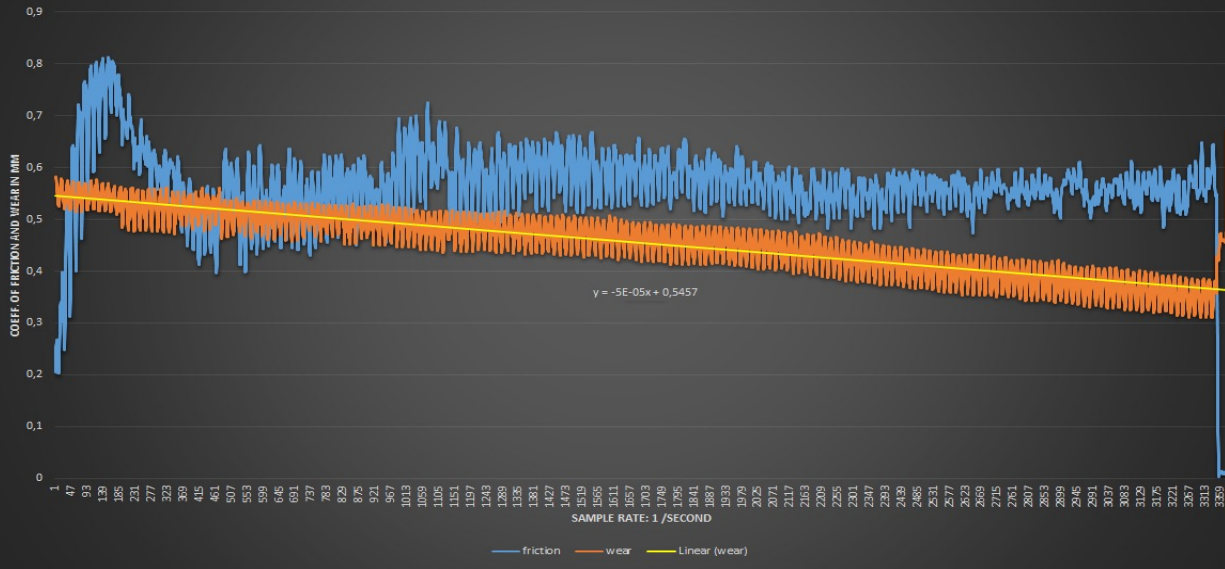
Tribo behaviour 42CrMo4 hardened pin on 100Cr6 hardened wheel  
dry (57 % RH), 12.4 mm/s , 422 MPa

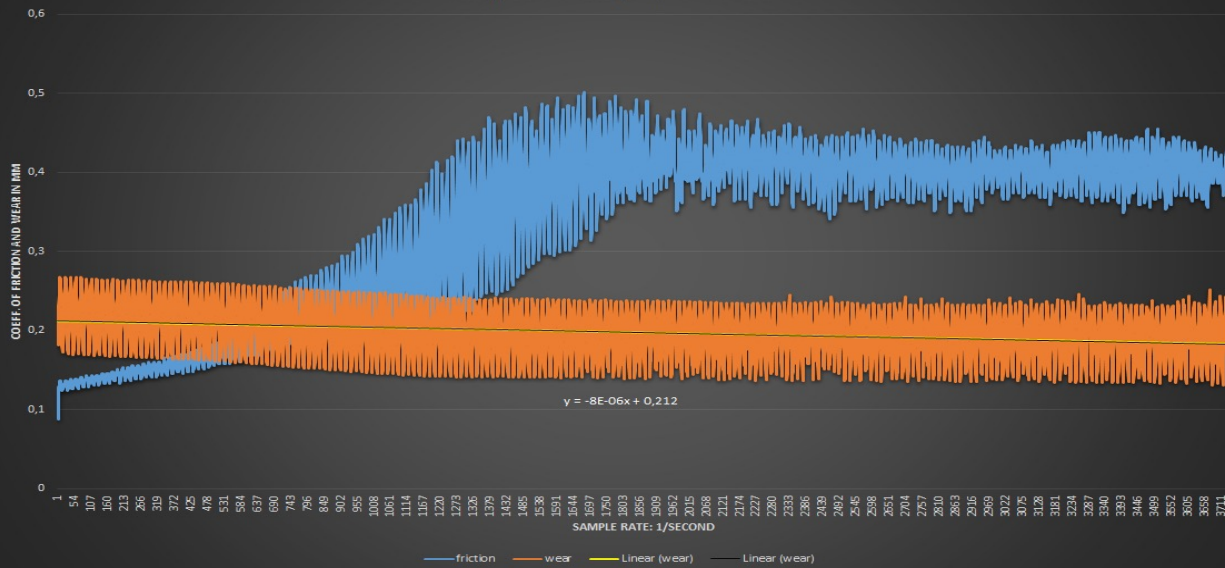
Lunac 2+  
stabilisation of  
C.O.F., the effect of  
a patina layer and  
the anti-galling  
characteristic

Tribo behaviour 42CrMo4 hardened pin on Lunac 2+ hardened wheel dry (57 %  
RH), 12.4 mm/s , 422 MPa

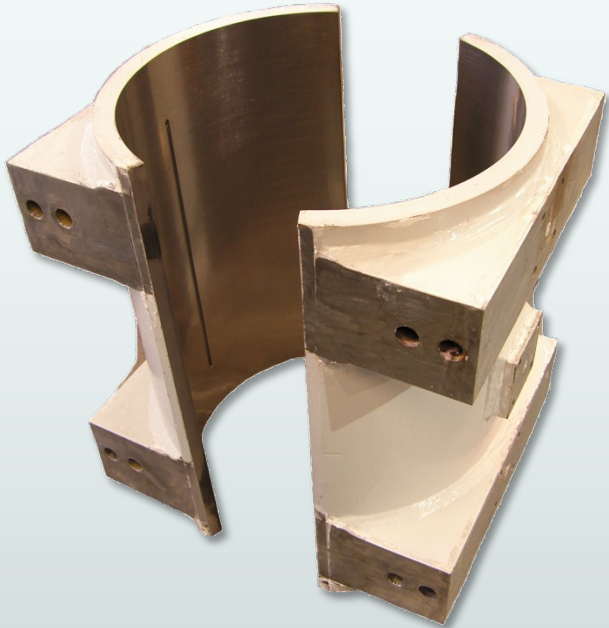
Disk spring guidance (Ketelbrug).  
Lunac 2+ coated for reasons of  
anti-fretting/anti-galling and stable  
coefficient of friction

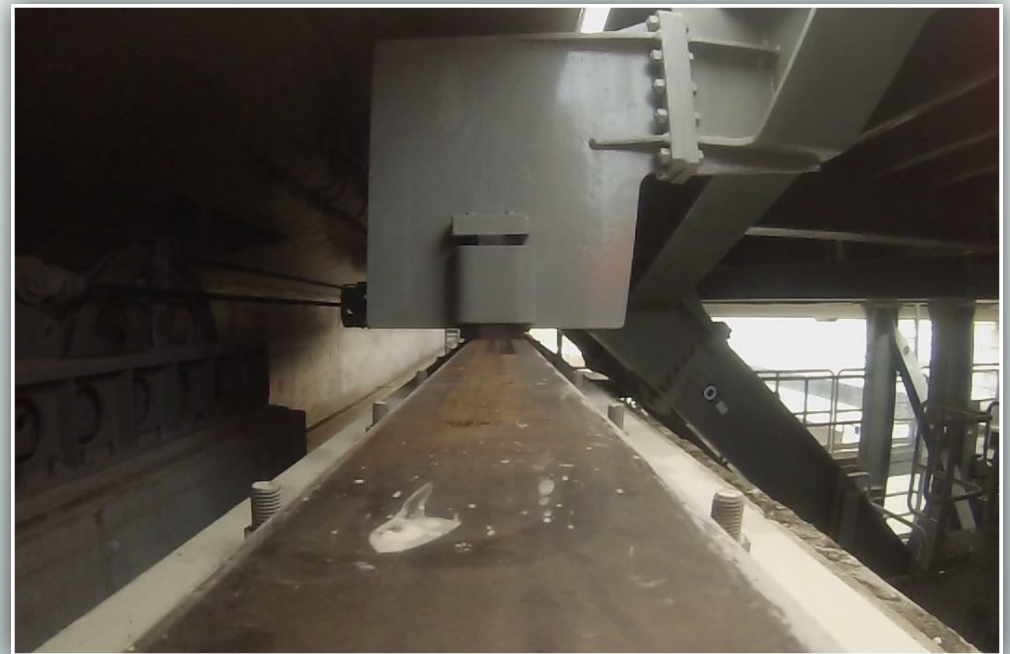
Lunac 2+ applied to the new Panama main lock door rail system after 3 years, to prevent the system from corrosion and especially adhesive wear (25 mm side shift during filling locks and earthquakes). Vertical load during lateral movement: up to 975 kN. Wheel-pressure up to 560 MPa.

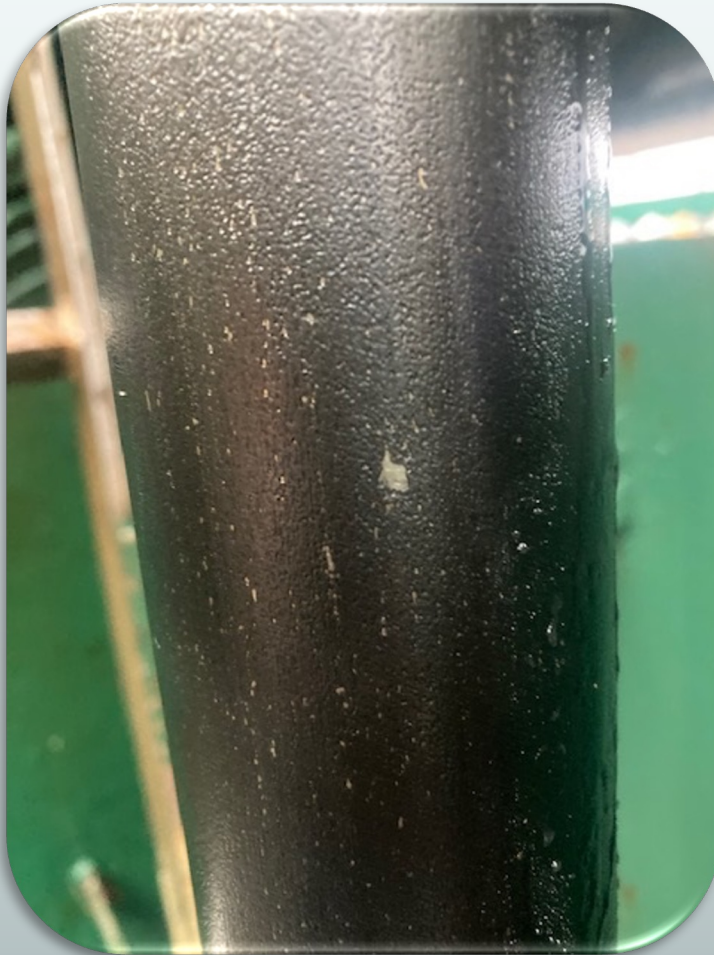
## Experienced limitation

Severe bending (30 mm !) of a L=1500 piston rod can create micro-cracks in the coating and finally expose a massive amount of the steel substrate. L2+D protected the substrate 2 years by its sacrificial cathodic protection behaviour. Still no substrate corrosion, but the coating turned rough.

If such severe bending cannot be prevented, lasercladding is recommended.

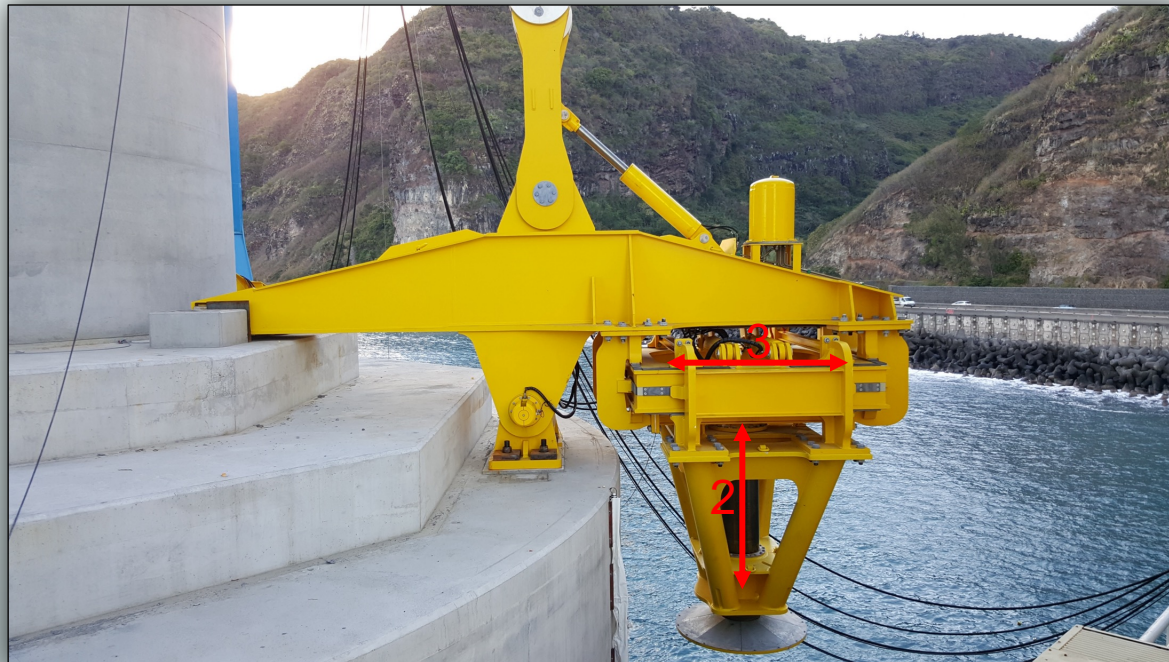
- Installation of gravity base (up to 4800T)
- Lifted and lowered using overhead crane
- Touchdown and positioning using Pile Positioning System:
  1. Lower base above seabed ~300mm
  2. Extend spuds to lock on seabed
  3. Positioning of base in XY plane using cylinders

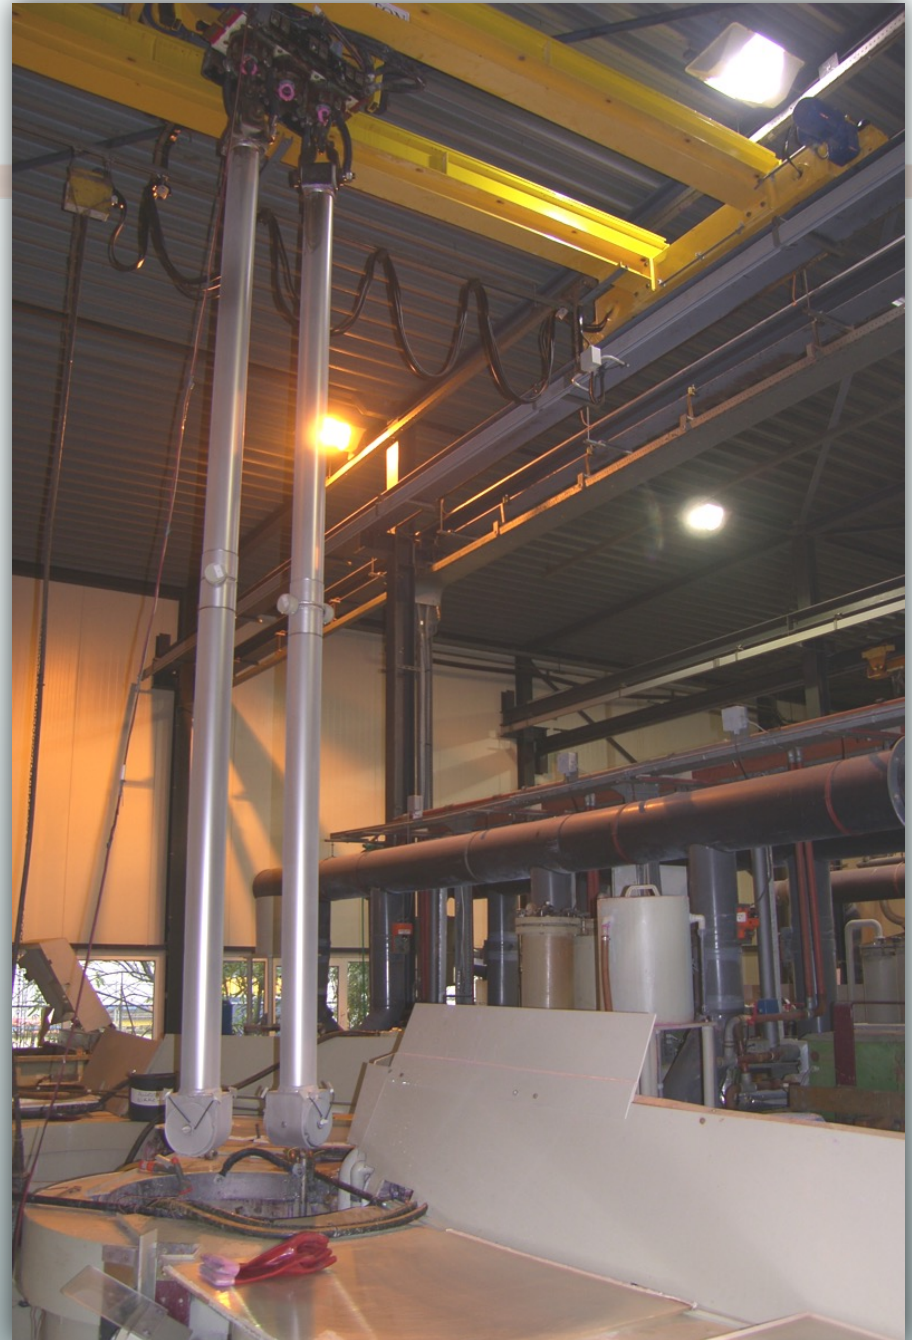
## **L2+D final plating result.**

Check out the revolving system (goal: perfect circumference coating distribution) and the support systems at the rod ends.
